Mass Movements in the Loja Basin – Ecuador, South America

CASE STUDY OF REINALDO ESPINOSA AREA

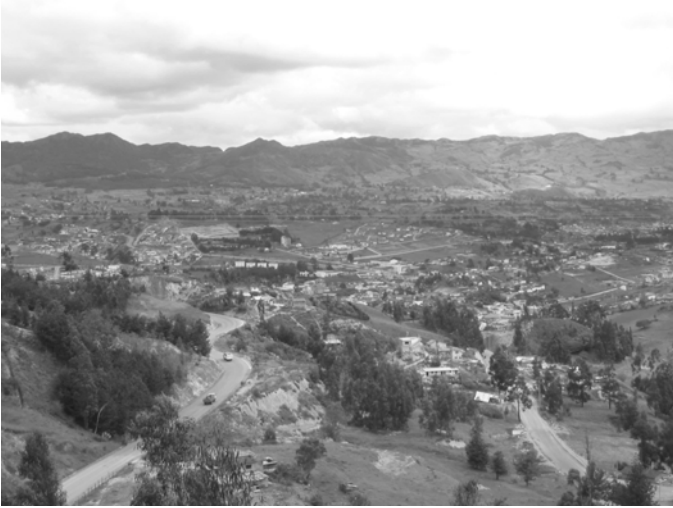
Figure 2: Panorama of Loja from E to W

The morphology of the basin is changing rapidly because of urban expansion. New construction along the flanks of the cordilleras are increasing the grade of instability of areas susceptible to landslides because of undercutting slopes. Many of these areas have been identified by air photograph interpretation and field observations (Figure 2).

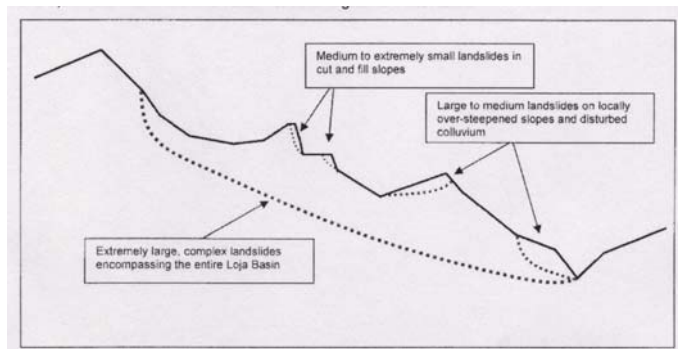
Figure 3: Schematic illustration of landslide mechanisms in Loja Basin

The zone is subject to numerous mass movement processes exhibiting different mechanisms, volumes, and movement rates. The largest landslides are extremely large (greater than 1,000,000 m³ in volume) and extend from the valley bottom to the upper margins of the Loja Basin (Figure 3). The mechanism of failure is not fully understood but appears complex; involving a combination of structurally controlled translational sliding, as well as rotational sliding and some flow-type behavior in the disturbed colluvium. The base of translational sliding probably corresponds to a clay-rich shale, but could also involve deformation along relict thrust faults.

probably more active during the late epoch of the Loja Basin construction. Detailed inspection along the upper margins of the basin, however, shows that many of the landslides continue to be active and move at rates exceeding 16 mm/yr (Figure 3). The instability of these landslides may be increasing as a result of urbanization, drainage alteration and, potentially, climate change.

Large to medium size landslides tend to be more active and move at slow rates (1.6 m/yr to 13 m/year). They are present along most slopes that have been over-steepened as a result of stream downcutting near the valley bottom, as well as on blocks rotated by the extremely large landslides (Figure 3)

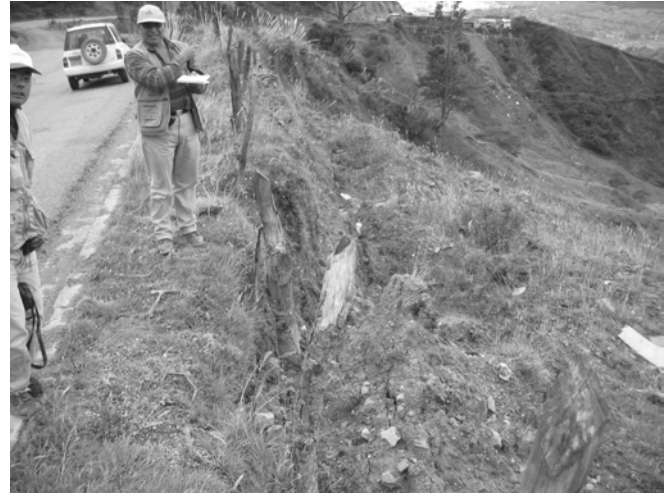
Figure 4: Unstable area along the margin of Loja Basin

Anthropogenic activity in some cases increase the instability of the slopes, when some infrastructure is constructed without any prevention or mitigation measures, mainly along the borders of the basin where urban expansion is increasing very fast (Figure 4)

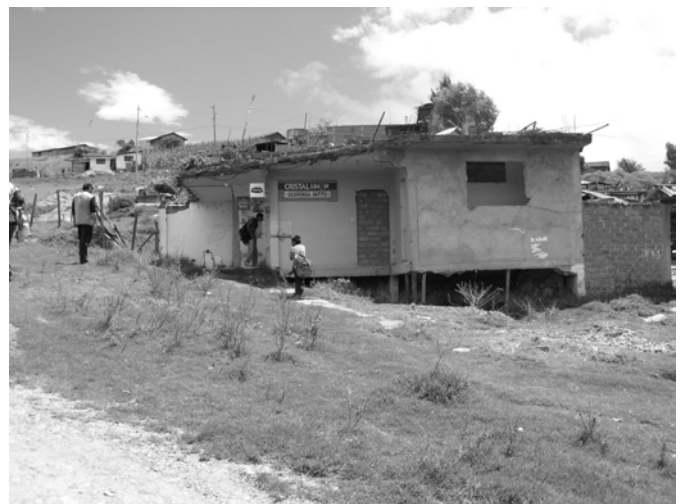
Figure 6: Damaged House in Reinaldo Espinosa area

According to the people living in the area, approximately in May of 1999, the Ciudadela Reinaldo Espinosa was affected by a landslide at the top of the slope where there are water supply reservoirs. Between March and April of 2001 a second landslide occurred, which affected some houses in the area (Figure 6).

According to the observations it seems that there are some cracks at the base of the tanks and water is filtering in the soil contributing in the instability of the area.

The residents describe that part of their houses were separated approximately 1 meter during a period of 2 months, corresponding to a slow rate of movement (1.6m/yr to 13m/yr).

Preliminary evaluation suggests that the onset of movement corresponds with the end of the rainy season, at which time the soil is likely saturated and the slope is no longer in a state of limit equilibrium. The community is considering installing a drainage system to prevent movements in the future, but further evaluation is required to determine if this solution will be effective and will provide the greatest cost-benefit. It is not clear if it is the best solution or if it is going to work.

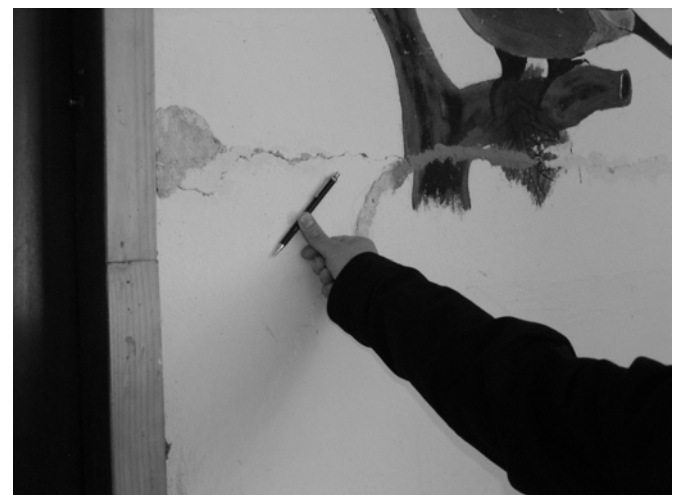
Figure 7: Cracks in the wall of a house in Reinaldo Espinosa area

It is still possible to see cracks in the walls of some houses, deformed structures, and walls totally destroyed by slope movements (Figure 7).

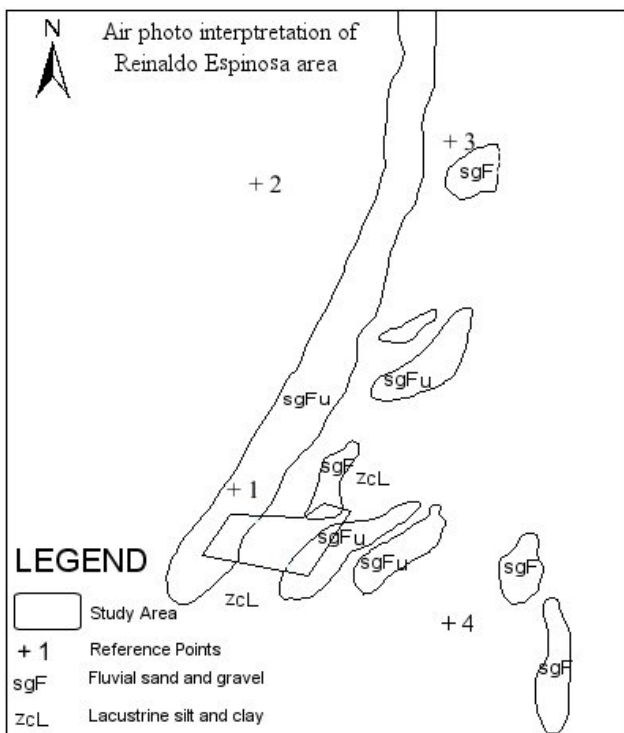
Figure 8: Air photo interpretation of Reinaldo Espinosa Area

The stream valleys have an asymmetric V-shaped as a result of the geological faults (Figure 8).

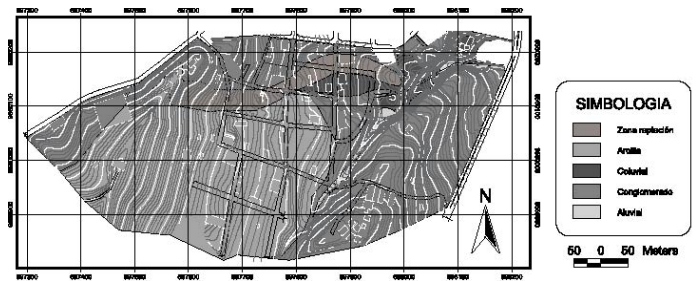
Figure 9: Geology of Reinaldo Espinosa Area

Bedrock geology comprises conglomerates, which outcrop through out of the area. They contain poorly sorted clasts of schist, quartzite, and quartz veins within clayey sand matrix. The thickness of the conglomerates in this area is over 45 meters (Figure 9).

A clay-rich shale lens may form the base of the landslide.

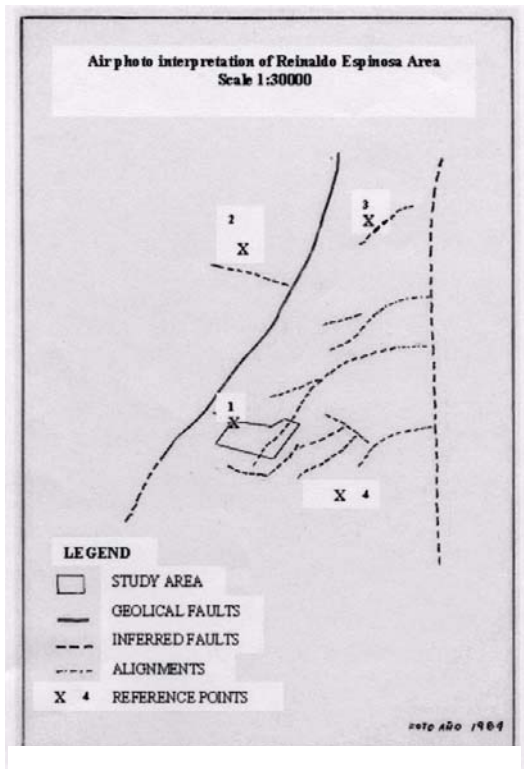
The area exhibits some alignment structurally-controlled: the principal corresponds to a stream, which flows N33E, bordering the two conglomerate blocks described before and likely caused by a vertical displacement between them; the second alignment corresponds to the landslide with preferential direction NE-SW, which is cutting the other alignment forming a wedge (Figure 10)

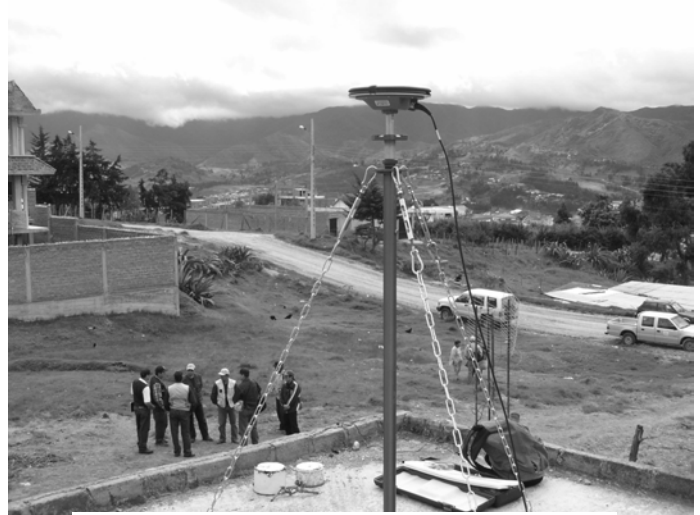
Figure 11: Control and monitoring points

Some monitoring and control points were established in Loja Basin, mainly in the Reinaldo Espinosa area, to gain a better understanding of the movement of unstable areas using Differential GPS. The first monitoring campaign was made in May 2004, the second in June and the third in September (Figure 11). The obtained data reveals that there is not any change between each monitoring campaign.

This work will be to be carried out on regular basis by DINAGE staff and members of other regional institutions to investigate temporal and spatial variations between each campaign of monitoring and to help minimize the risk to people living in the Reinaldo Espinosa area.
