Mass Movements in the Loja Basin – Ecuador, South America

ABSTRACT: The Loja Basin comprises a north-south orientated, elongate valley, bounded by the Cordilleras Real and Occidental of the Ecuadorian Andes. Most of the area is inhabited, and includes the city of Loja. Geologically it comprises metamorphic rocks from Paleozoic age overlaid by sedimentary rocks, from Miocene/Pliocene age, in faulted and discordant contact. The Loja Basin is subject to mass movement processes with different mechanisms, volumes and movement rates. The biggest landslides involve almost the entire margins of the city. They are complex, extremely slow and are continuously active. The grade of instability may have increased by the construction of infrastructure like houses, roads and irrigation channels. Considering the hazard and vulnerability grade of the zone, the Multinational Andean Project-Geosciences for the Andean Communities MAP-GAC chose the ciudadela Reinaldo Espinosa as a Pilot Area for developing a detailed investigation, which is being carried out by the Dirección Nacional de Geología DINAGE in cooperation with the Universidad Técnica Particular de Loja UTPL and the Programa Regional de Des

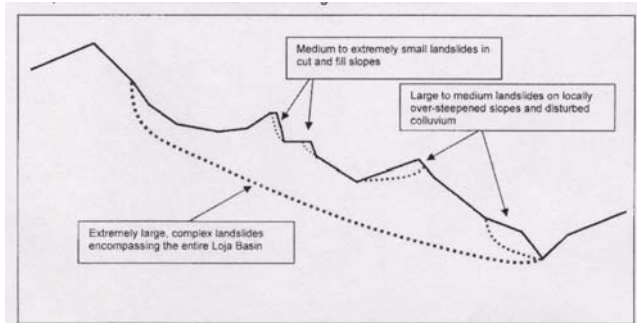
The zone is subject to numerous mass movement processes exhibiting different mechanisms, volumes, and movement rates. The biggest landslides are extremely large (greater than 1,000,000 m³ in volume) and extend from the valley bottom to the upper margins of the Loja Basin (Fig. 3). The

mechanism of failure is not fully understood but appears complex, involving a combination of structurally controlled translational sliding, as well as rotational sliding and some flow-type behavior in the disturbed colluvium. The base of translational sliding probably corresponds to a clay-rich shale, but could also involve deformation along relict thrust faults.

Large to medium size landslides tend to be more active and move at slow rates (1.6 m/yr to 13 m/year). They are present along most slopes that have been over-steepened as a result of stream downcutting near the valley bottom, as well as on blocks rotated by the extremely large landslides (Fig. 3).

Figure 3. A schematic illustration of landslide mechanisms in the Loja Basin.

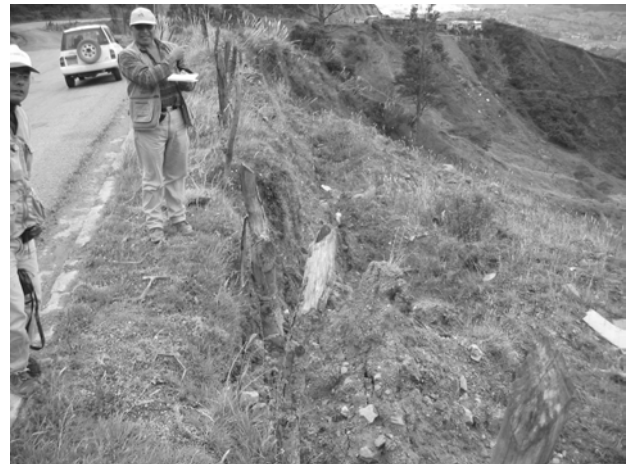
Anthropogenic activity in some cases increases the instability of the slopes, when some infrastructure is constructed without any prevention or mitigation measures, mainly along the borders of the basin where urban expansion is increasing very fast (Fig. 4).

Figure 4. An example of an unstable area along the margin of Loja Basin.

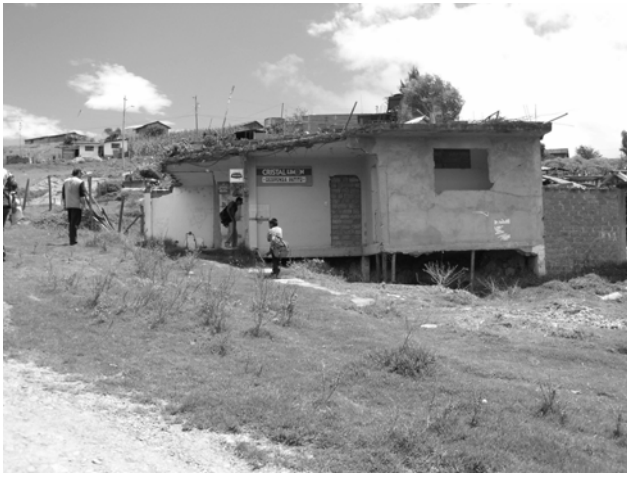
According the people living in the area, approximately in May 1999, the Ciudadela Reinaldo Espinosa was affected by a landslide at the top of the slope where there are water supply reservoirs. Between March and April 2001 a second landslide occurred, which affected some houses in the area (Fig. 6).

According the observations it seems that there are some cracks at the base of the tanks and water is filtering in the soil contributing in the instability of the area.

The residents describe that part of their houses were separated by approximately 1 meter during a period of 2 months, corresponding to a slow rate of movement (1.6m/yr to 13m/yr).

Figure 6. Damaged House in Reinaldo Espinosa area.

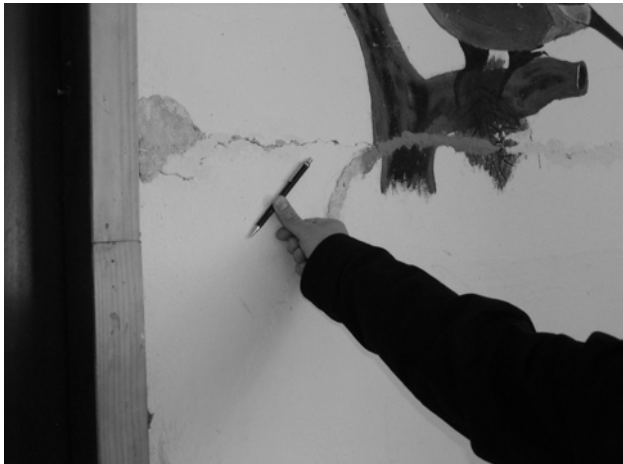
It is still possible to see cracks in the walls of some houses, deformed structures, and walls totally destroyed by slope movements (Figure 7). Preliminary evaluation suggests that the onset of movement corresponds with the end of the rainy season, at which time the soil is likely saturated and the slope is no longer in a state of limit equilibrium. The community is considering installing a drainage system to prevent movements in the future, but further evaluation is required to determine if this solution will be effective and will provide the greatest cost-benefit. It is no clear if it is the best solution or if is going to work.

Figure 7. Cracks in the wall of a house in Reinaldo Espinosa area.
