Mass Movements in the Loja Basin – Ecuador, South America

ABSTRACT: The Loja Basin comprises a north-south orientated, elongate valley, bounded by the Cordilleras Real and Occidental of the Ecuadorian Andes. Most of the area is inhabited, and includes the city of Loja. Geologically it comprises metamorphic rocks from Paleozoic age overlaid by sedimentary rocks, from Miocene/Pliocene age, in faulted and discordant contact. The Loja Basin is subject to mass movement processes with different mechanisms, volumes and movement rates. The biggest landslides involve almost the entire margins of the city. They are complex, extremely slow and are continuously active. The grade of instability may have increased by the construction of infrastructure like houses, roads and irrigation channels. Considering the hazard and vulnerability grade of the zone, the Multinational Andean Project-Geosciences for the Andean Communities MAP-GAC chose the ciudadela Reinaldo Espinosa as a Pilot Area for developing a detailed investigation, which is being carried out by the Dirección Nacional de Geología DINAGE in cooperation with the Universidad Técnica Particular de Loja UTPL and the Programa Regional de Des

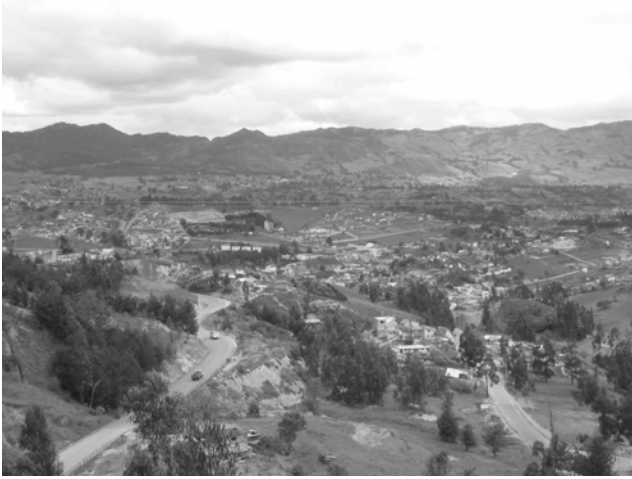
Figure 2. Panorama of Loja from E to W.

The morphology of the basin is changing rapidly because of urban expansion. New construction along the flanks of the cordilleras is increasing the grade of instability of areas susceptible to landslides because of slope undercutting. Many of these areas have been identified by air photograph interpretation and field observations (Fig. 2).

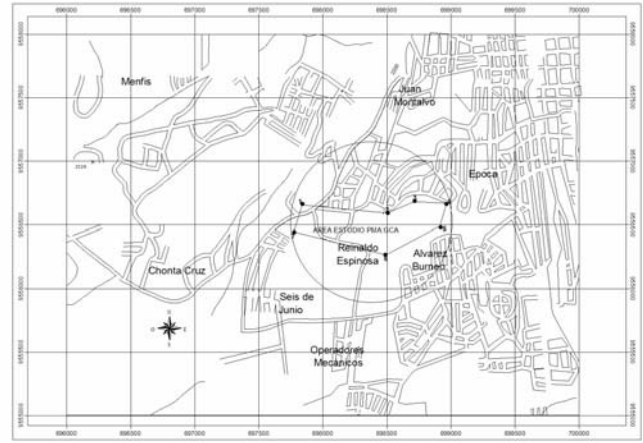
Figure 5. Location of Reinaldo Espinosa area.

The investigation area (Fig. 5) is located in the southwest portion of the Loja Basin and within the city of Loja. The coordinates are:

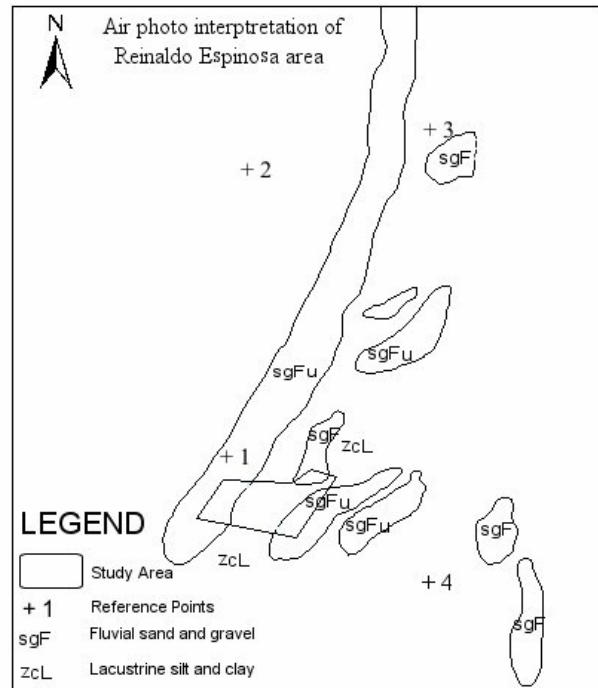
Figure 8. Air photo interpretation of Reinaldo Espinosa area.

The second block in the border of Eugenio Espejo Avenue shows a gentle slope with some hummocks and elongated forms in the central part as a result of slope movement to the Southwest

The stream valleys have an asymmetric V-shaped as a result of the geological faults (Fig. 8).

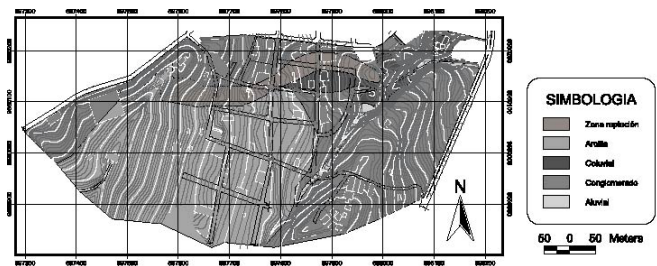
Figure 9. Geology of Reinaldo Espinosa area.

Bedrock geology comprises conglomerates, which outcrop through out of the area. They contain poorly sorted clasts of schist, quartzite, and quartz veins within clayey sand matrix. The thickness of the conglomerates in this area is over 45 meters (Fig. 9).

There are some intercalations of shale and siltstone within the conglomerates, varying in thickness between 1 and 2 meters.

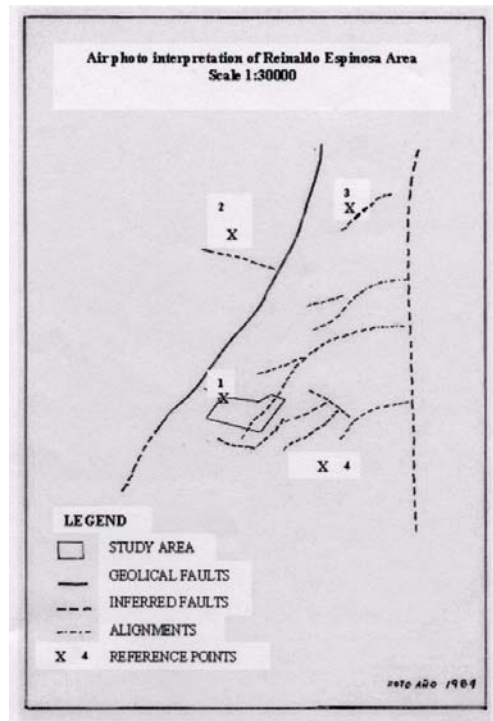
Figure 10. Structural geology of the area.

The area exhibits some alignment that is structurally-controlled: the principal corresponds to a stream, which flows N33E, bordering the two conglomerate blocks described before and likely caused by a vertical displacement between them; the second alignment corresponds to the landslide with preferential direction NE-SW, which is cutting the other alignment forming a wedge (Fig. 10). These blocks form a depression of the terrain, which has been infilled by sandy colluvium and washed material with slight lithification and high permeability. They could be the result of tectonic activity of the faults in the past.

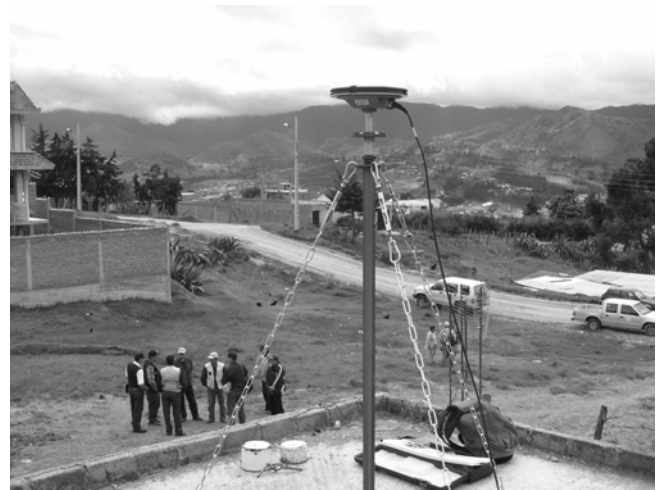
Some monitoring and control points were established in Loja Basin, mainly in the Reinaldo Espinosa area, to gain a better understanding of the movement of unstable areas using differential GPS. The first monitoring campaign was made in May 2004, the second in June and the third in September (Fig. 11). The obtained data reveals that there is no change between each monitoring campaign.

Figure 11. Picture showing an example of a control and monitoring point.

This work will be to be carried out on regular basis by DINAGE staff and members of other regional institutions to investigate temporal and spatial variations between each campaign of monitoring and to help minimize the risk to people living in the Reinaldo Espinosa area.
